Manhole Inspection Summary

Manhole # S25AA_012MH

Insp Date: **11/26/07 3:55 PM**

Location Address: **1014 LAFAYETTE AVE**

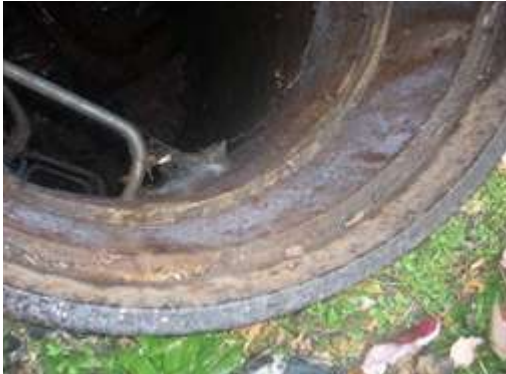
Defect 1

Frame Offset: **0.5** (in.) Condition: ☒ Sound ☐ Cracked ☐ Leaks

FRAME OFFSET

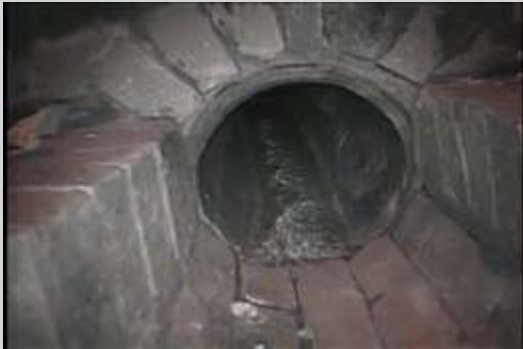
12 O'Clock Outflow

8 in. Circular Gravity Sewer
Pipe Out @ 12 O'Clock

Pipe Height: **8.4** (in.) Rod and Bar (Angled)
Pipe Material: **Clay** ☐ Pipe Lined
Invert Depth: **10.55** (ft.) Flow Characteristics: **Slow**
Deposits: ☒ None ☐ Mud ☐ Sludge ☐ Debris ☐ Grease
Silt Depth: (in.) Deposits Extent:
Infiltration: **None** Pipe Seal Cond: **Sound**

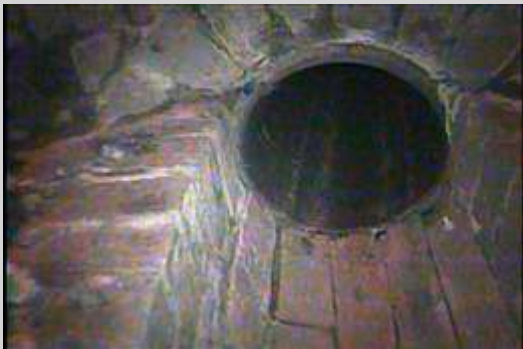
9 O'Clock Inflow

8 in. Circular Gravity Sewer
Pipe In @ 9 O'Clock

Pipe Height: **7.2** (in.) Rod and Bar (Angled)
Pipe Material: **Clay** ☐ Pipe Lined
Invert Depth: **10.01** (ft.) Flow Characteristics: **Slow**
Deposits: ☒ None ☐ Mud ☐ Sludge ☐ Debris ☐ Grease
Silt Depth: (in.) Deposits Extent:
Infiltration: **None** Pipe Seal Cond: **Sound**
